Dental Transfixation: Clinical Case Report

This study aimed to report a clinical case, demonstrating the transfixation of a root fracture on tooth 11 due to trauma by contact sport, using glass fiber post and composite resin. The results obtained were quite satisfactory, restoring tooth function and esthetics, recovering the patient's oral health.

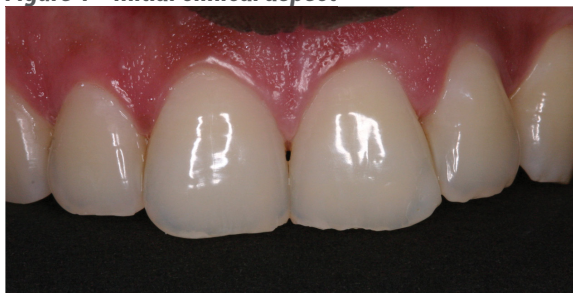
Figure 1 - Initial clinical aspect

Male patient, 26 years old, arrived at the Dental Clinic of the Dentistry Course at Universidade Severino Sombra, in Vassouras/RJ-Brazil, complaining of pain. The patient reported that he was an MMA (mixed martial arts) fighter and was looking routine care. After a radiographic examination, a vertical fracture was diagnosed on the root of tooth 21. Clinical examination showed an aspect of normality in the clinical crown and gum tissue (Figures 1 and 2).

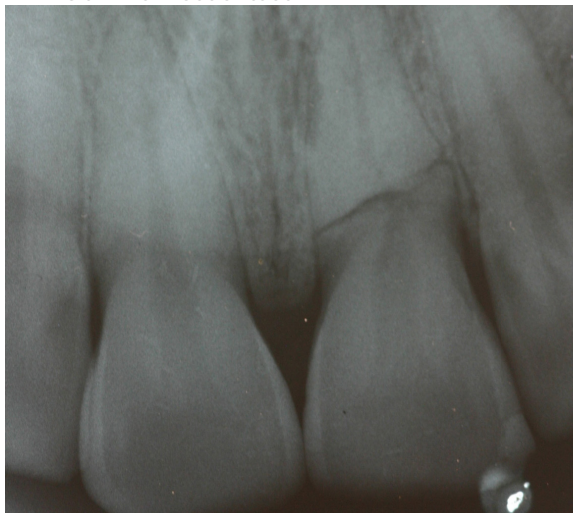
Figure 2 – Vertical fracture in the middle third on root of tooth 21

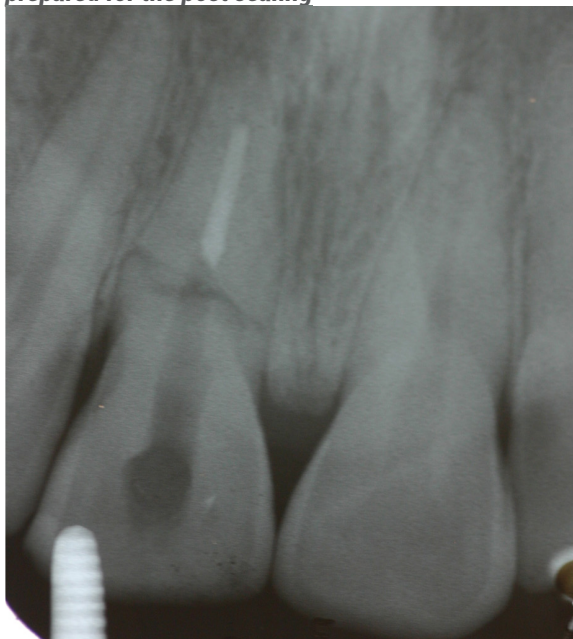
Figure 3 – Canal treated and prepared for the post sealing

In the following clinical session, the endodontic treatment was conducted with the help of an operative microscope. Seven days later, the transfixation procedure with a prefabricated glass fiber post (Tampered Exacto, Angelus, Brazil) was performed. The canal was prepared, clearing two thirds of the endodontic treatment (Figure 6). The post #2 was selected and cut so the crown portion of the tooth could be filled (Figures 3, 4 and 5).

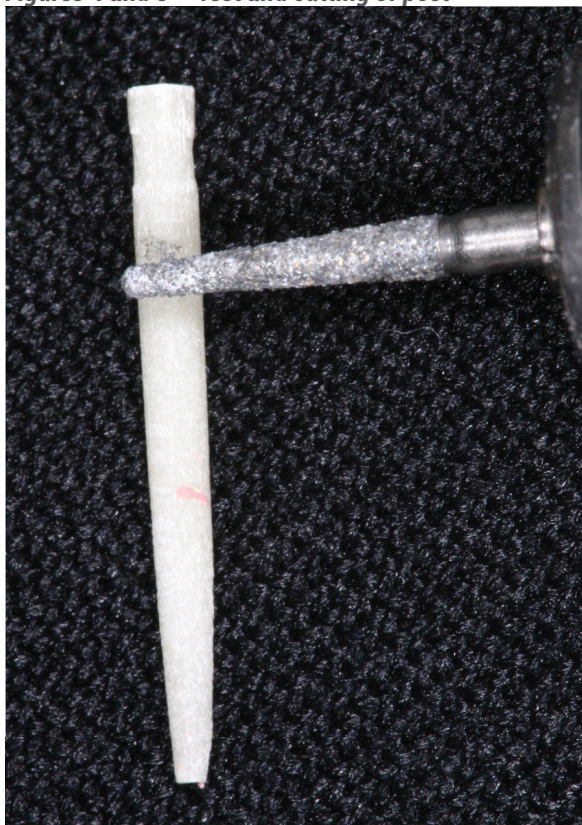
Figures 4 and 5 – Test and cutting of post

After cutting the post, silane agent (Angelus, Brazil) and BISGMA adhesive (Fusion Duralink, Angelus, Brazil) were applied. In the canal, Phosphoric Acid 37% (Angelus, Brazil) was applied for 30 seconds, rinsed and dried with help of paper cones and the adhesive system (Fusion Duralink, Angelus, Brasil) was applied. Resin sealer was prepared (Cement Post, Angelus, Brazil) and inserted into the radicular canal with a Centrix syringe. The post was adapted to the canal, after insertion of the sealer, waiting for chemical polymerization of the sealer. Finally, the tooth crown portion was filled with micro hybrid composite resin (Charisma Diamond, Heraeus, Germany) in color A2 and light cured for 20 seconds (figures 4, 5 and 6).

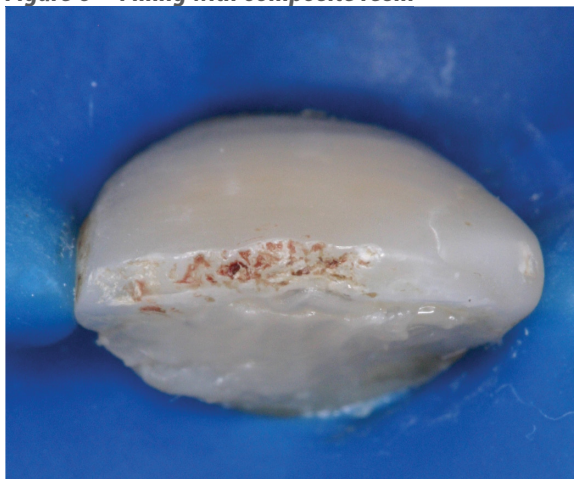
Figure 6 – Filling with composite resin

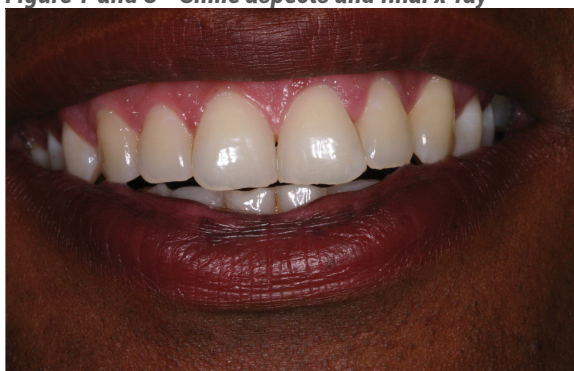
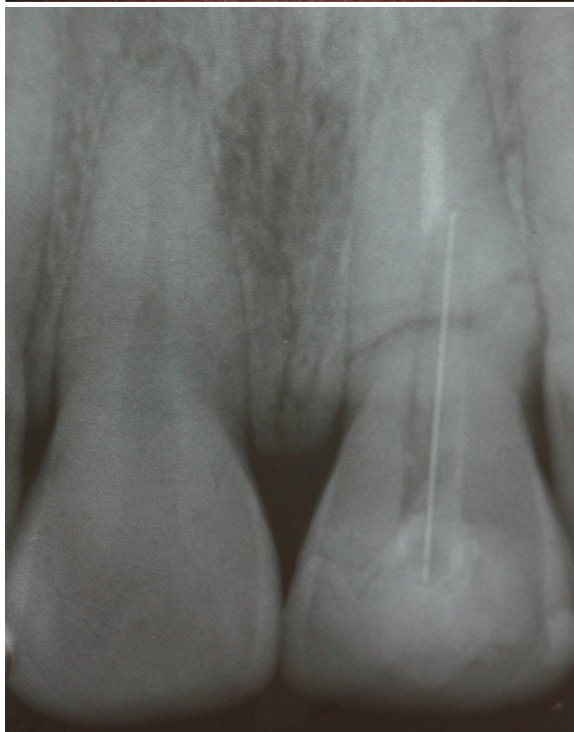
Figure 7 and 8 - Smile aspects and final x-ray

Then, occlusal adjustments were performed and subsequent finishing of the restoration. A final x-ray was taken, observing the success of the treatment and the patient was instructed to return every six months for treatment maintenance (Figure 7).
