Perforation treatment using the new MTA Repair HP: Clinical Case Report

Clinical Case Report

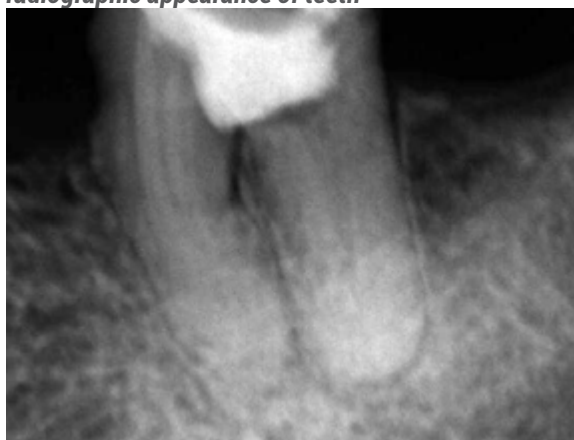
Female patient, 47 years old, presented with a clinical picture of extensive iatrogenic perforation of the furcation region of the dental element 36 (Figures I and II), associated with radiographic bone loss, vestibular fistula and pain on palpation. The patient reported history of having been previously subjected to an urgent intervention in this tooth by other professional, as it presented acute pain characteristic of pulpitis.

Figures I and II - Initial clinical and radiographic appearance of teeth

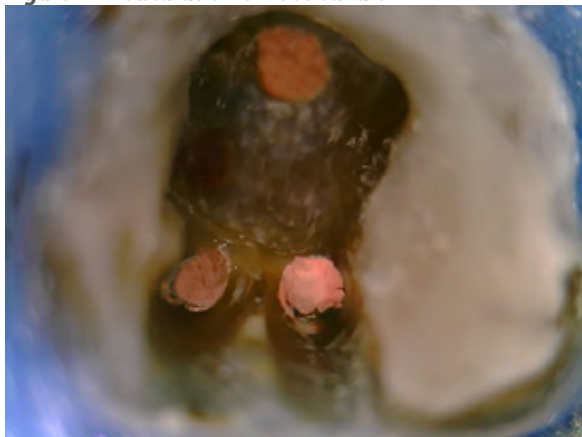
The sealing was performed using the thermomechanical Hybrid Tagger technique (Figure III), by employing GutaCondensor (Maillefer/Switzerland), TP gutta-percha cones (Dentsply/Brazil) and MTA-based sealer Fillapex (Angelus/Brazil). After thermo compaction, the obturation cutting was performed, as

Figure III - Obturation of root canals.

well as vertical condensation using cold pusher; and again the region of the perforation was cleaned and filled with Calcium Hydroxide.

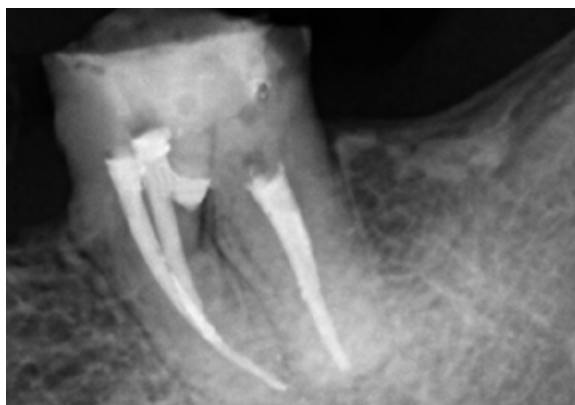
Figures IV and V - Clinical and radiographic appearance of perforation filling with MTA Repair

After 15 days, again, we proceeded to seal the region, and initially verified the proper possibility of drying the area. The filling of the perforated region was carried out with the use of MTA Repair HP (Angelus/Brazil), previously prepared as recommended by the manufacturer, and it was inserted using an MTA Applicator (Angelus/Brazil). Clinical and radiographic criteria were used to determine the correct filling using the material (Figures IV and V); and the glass ionomer cement (Vitremer/3M/USA) used for the protection of the sealed region (Figure VI).

After the temporary restoration, radiographically it was observed proper sealing of furcation region by MTA Repair HP, as well as no postoperative complications.

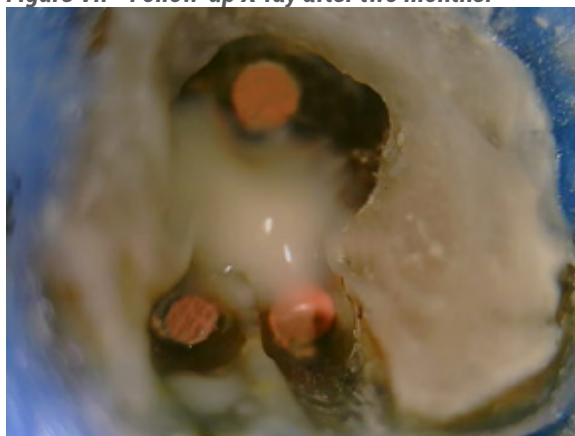
Follow up was conducted after two months, observing bone neoformation in the furcation region and absence of symptoms (Figure VII).

Figure VII - Follow-up X-ray after two months.
