Apexification treatment using MTA Repair HP: Clinical Case Report

Clinical Case Report

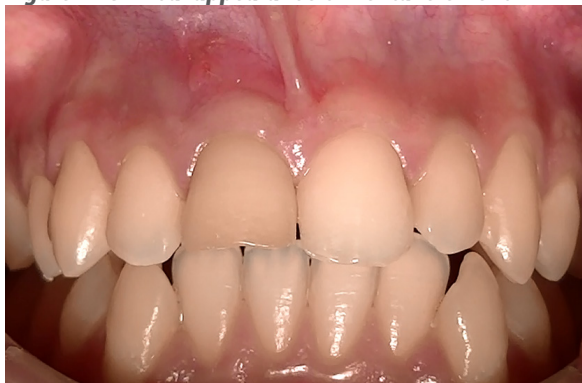
Figure I - Clinical appearance of dental element 11

Male patient, 28 years old, presented with asymptomatic clinical picture of chromatic alteration on dental element 11 (Figure I), reporting dental trauma history during childhood. Clinical and radiographic testing found traces of pulp necrosis (Figure II), and it was submitted to endodontic treatment.

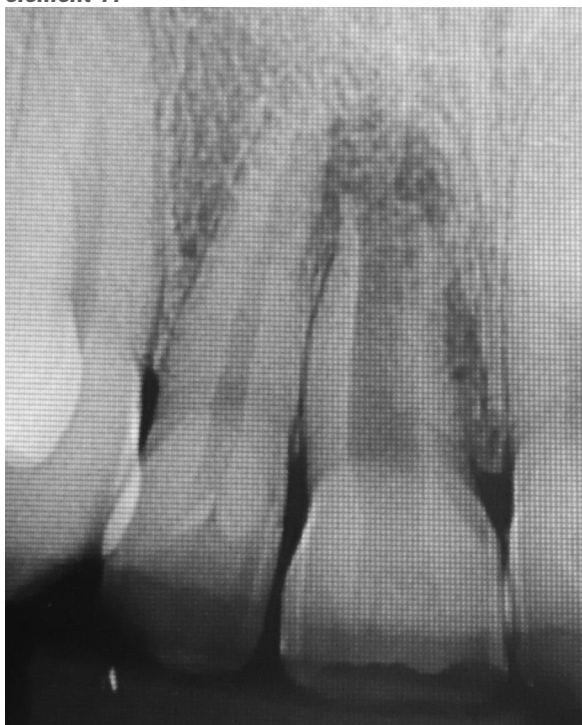
Figure II - Initial radiographic appearance of dental element 11

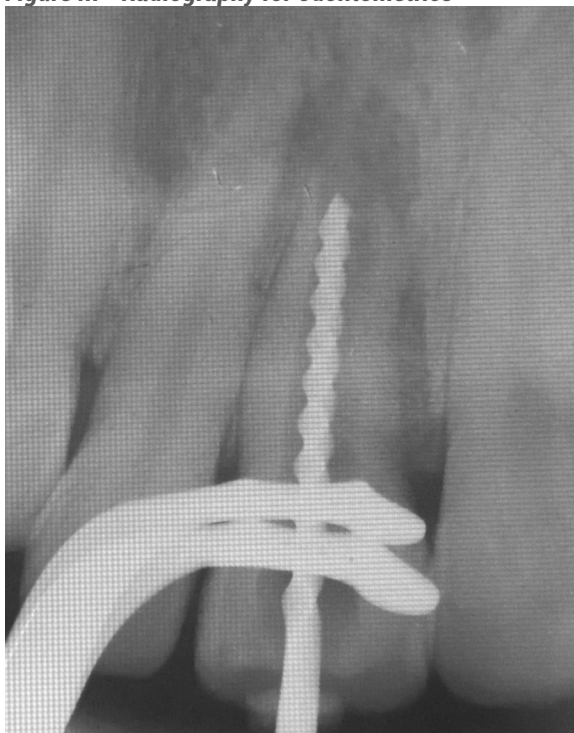
Figure III - Radiography for odontometrics

After the initial approach with the patient, anesthesia was given, followed by preparing absolute isolation. Subsequently, the coronary access was performed, where it was possible to clinically verify the presence of pulp necrosis. A crown-down disinfecting penetration was performed using as irrigator agent 2.5% NaOCl, and odontometry by radiographic method (Figure III), due to impossibility of using a foramen locator in these anatomical conditions, as it could influence its accuracy.

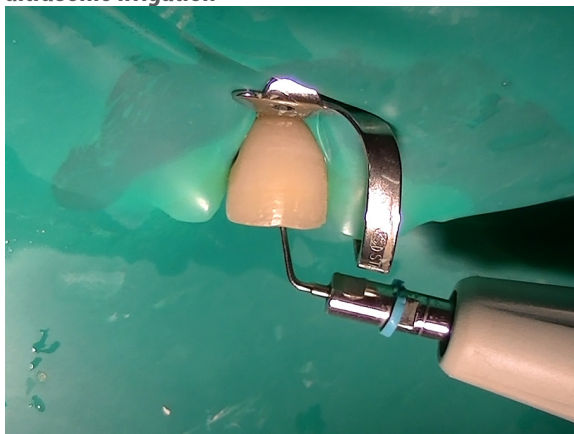
Figure IV - Supplementary cleaning process using ultrasonic irrigation

A manual preparation technique (step-back) was performed, using 3rd generation K Files (Maillefer/Switzerland), seeking to dilate the entire conformation of the root canal, and as irrigator agent 2.5% NaOCl. At each instrument exchange, passive ultrasonic irrigation was performed with flat inserts (Figure IV) in order to enhance the cleaning effect. As a complement to the

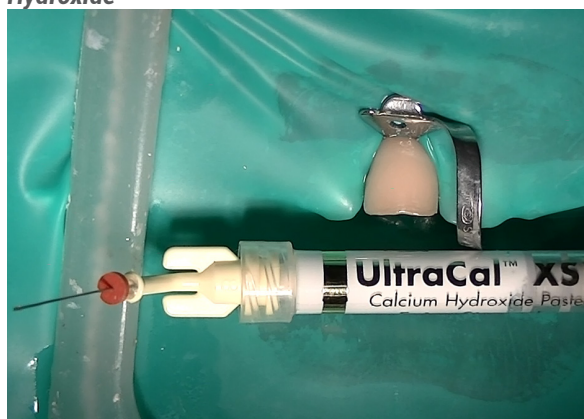
Figure V - Intracanal medication with Calcium Hydroxide

intra-channel decontamination process, two biweekly exchanges of Calcium Hydroxide (Ultracal/Ultradent/USA) were performed (Figure V), also with the purpose of analyzing quality of cleaning, through the radiopacity of the filling observed radiographically (Figure VI).

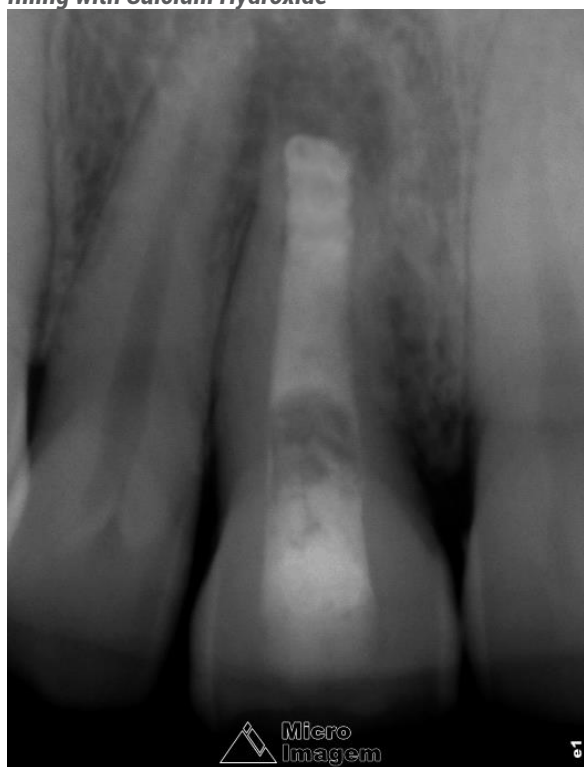
Figure VI - Radiographic appearance of root canal filling with Calcium Hydroxide

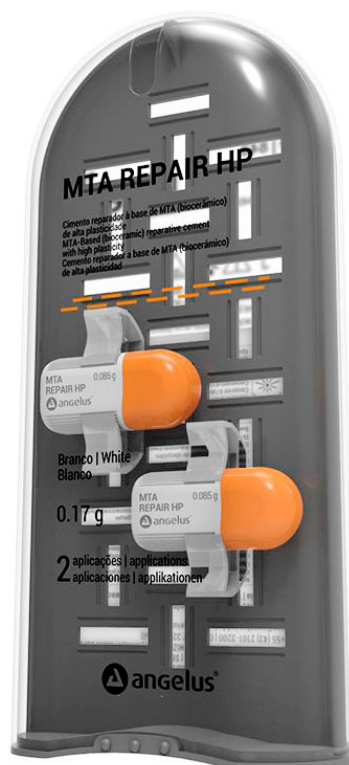
Figure VII - Presentation of MTA REPAIR HP (Angelus / Brazil)

After removal of intracanal medication and drying, the apical plug was prepared with MTA REPAIR HP (Angelus/Brazil) (Figure VII), and inserted through direct technique by employing previously measured endodontic condensers (Figure VIII), with the purpose of filling and subsequent sealing the apical 4 mm (Figure IX).

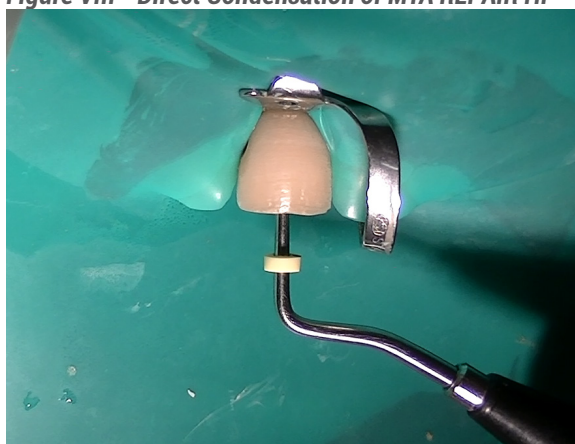
Figure VIII - Direct Condensation of MTA REPAIR HP

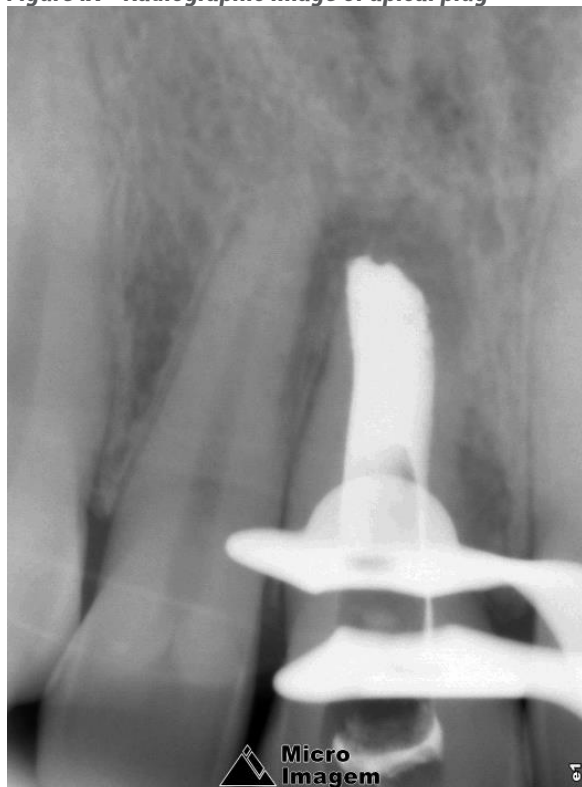
Figure IX - Radiographic image of apical plug

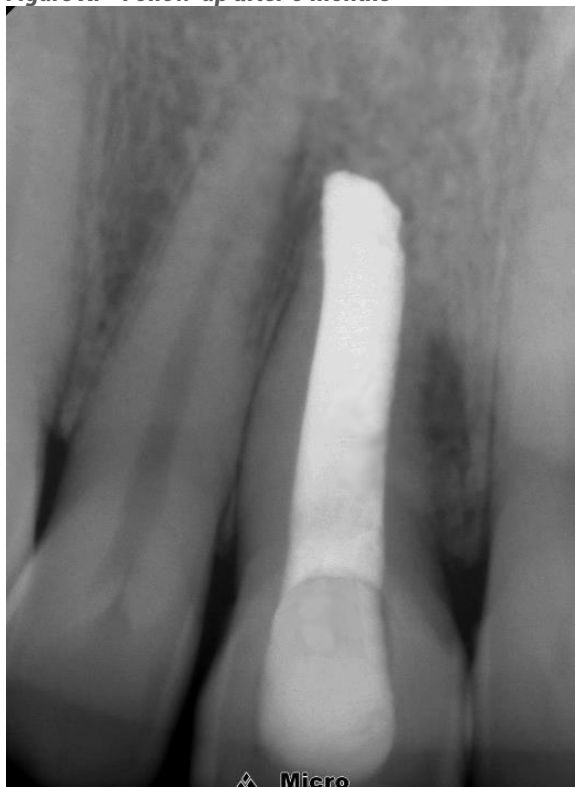
Figure XI - Follow-up after 6 months

After 24 hours, root canal filling was performed using Tagger's hybrid thermomechanical technique, with an MTA-based sealer, Fillapex (Angelus/Brazil). Radiographically, it was observed ideal sealing of the entire root canal area, as well as no postoperative complications (Figure X). Follow-up was conducted after six months, observing bone neoformation in the apical region (Figure XI).

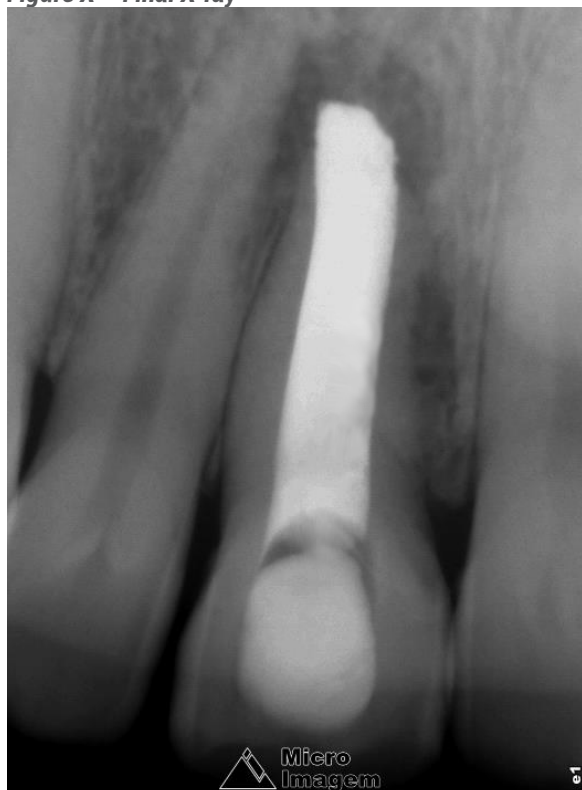
Figure X - Final X-ray
