ENDODONTIC RETREATMENT USING MTA-BASED SEALANTS IN A TOOTH WITH PERFORATION AND PERIAPIAL LESION

CLINICAL CASE REPORT

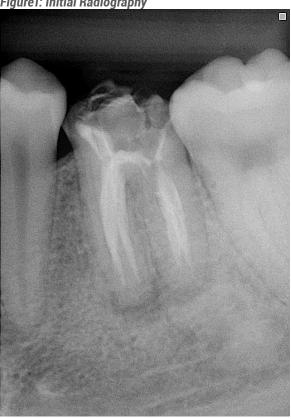
Figure1: Initial Radiography

Female patient, came to the dental office complaining of pain, for retreatment of element 36. Radiographically, it presented thickening of the periodontal ligament and periapical lesion in the mesial and distal roots, leading to the diagnosis of chronic apical periodontitis (Figure 1).

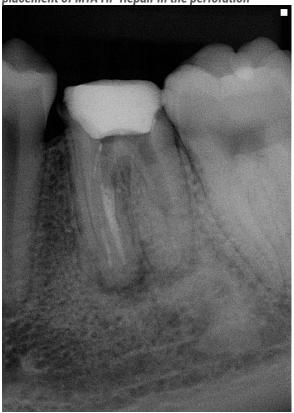
In the next session, the deviation in the mesio canal was filled with MTA HP Repair (Angelus Indústria de ProdutosOdontológicos, Paraná, Brazil) and glass ionomer (S.S. White Duflex, Rio de Janeiro, Brazil) to enable performing the instrumentation of canals avoiding the expansion of the perforation (Figure 3).

Figure 3: Radiographic aspect after the placement of MTA HP Repair in the perforation

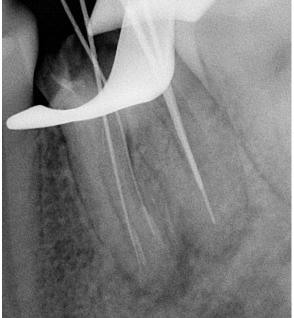
With anintervalof 4 weeks, patient asymptomatic, the working length was confirmed via apical and radiographic locator (Figure 4) and the perforation was filled again with MTA HP REPAIR (Angelus Indústria de ProdutosOdontológicos, Paraná, Brazil) (Figure 5 and 6) in order to increase the perforation protection (Figure 2B). Medication was changed inside the canals.

Figure 4: Odontometrics radiography

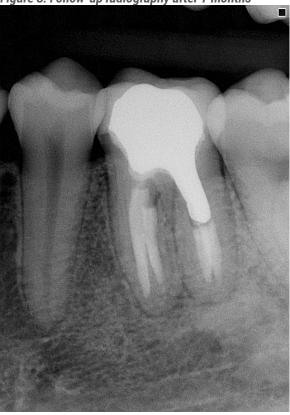
After 7 months of follow-up, the patient does not present, clinically, pain symptoms and radiographically there was repair of bone resorption in the mesial and distal roots (Figure 8).

Figure 8: Follow-up radiography after 7 months
