## Restoration of posterior teeth: direct composite resin in vital pulp teeth and fiberglass post in non-vital teeth.

Leonardo Fernandes da Cunha, Raiane Mayara Schmoeller Ferreira  
Carla Castiglia Gonzaga, Gisele Maria Correr Nolasco.

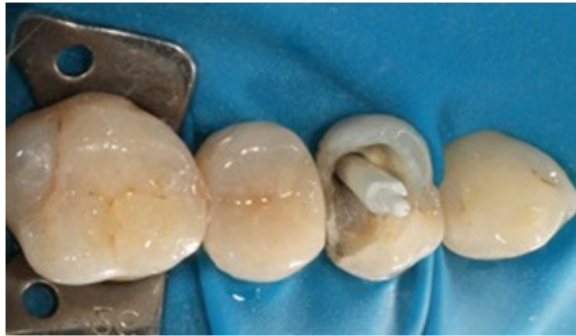
**Figure IIC –Note de prefabricared "sleeve" to promote better stability the post.**

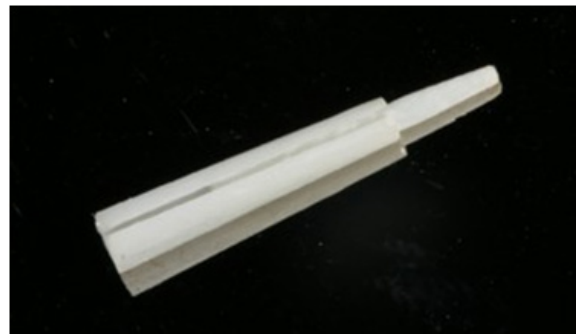
**Figure III- Fiberglass post removed from the root canal after testing. The "sleeve" will be cut tangent to the post.**

The first maxillary premolar showed adequate endodontic treatment, without periapical lesion. A fiberglass post system recently launched on the market - Splendor (Angelus) was selected. The root canal filling material was removed with Gates and Largo drills. The post was tested and the excess part of it was cut with a diamond disk.

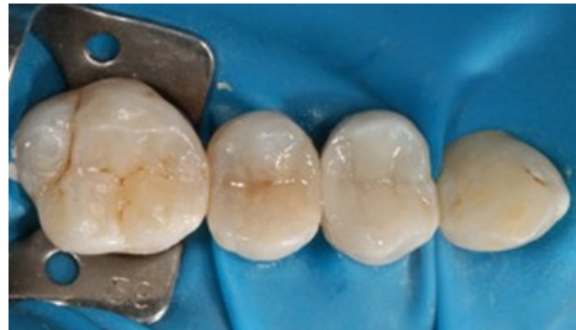
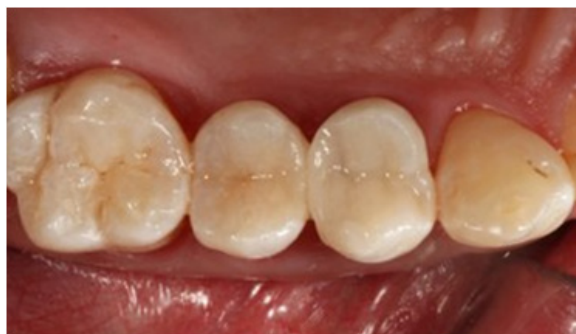
Fig. 4A and 4B: Observe the "chameleon effect" of the resin using only one color of the Charisma Diamond resin. Final aspect of the restorations after finishing and final polishing.

Several resins are available in the current market. In the presented case, Charisma Diamond nanohybrid resin was used. The two restored teeth showed satisfactory results. In addition, the resin presented a consistency of easy insertion and manipulation for posterior teeth, thus favoring the sculpture.
