Association of fiberglass post and core for immediate reconstruction of anterior teeth extremely destroyed

Fábio Sene, DDS; MS; PhD.

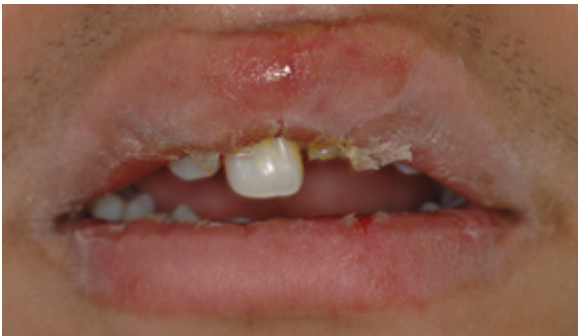
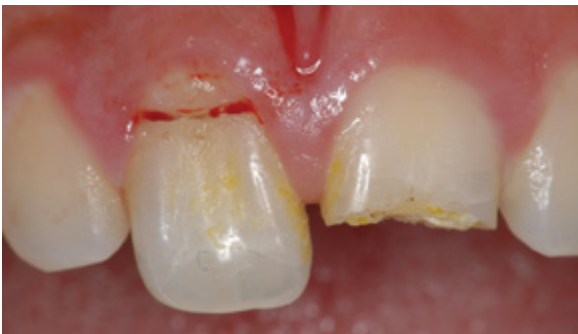
Figura 1.

Patient, male sex, 25 years old, sought dental attendance, with teeth 11 and 21 extensively fractured due to the accident (figures 01 and 02).

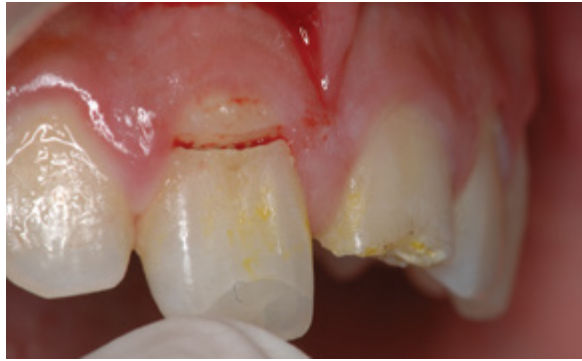
Figura 3.

During the clinical examination anamnesis, the fracture of the middle third of tooth 21 was noted without greater impairment, but in tooth 11 an extensive fracture was found, at the cervical level, with rupture of the neurovascular bundle and invasion of the biological space (figure 03).

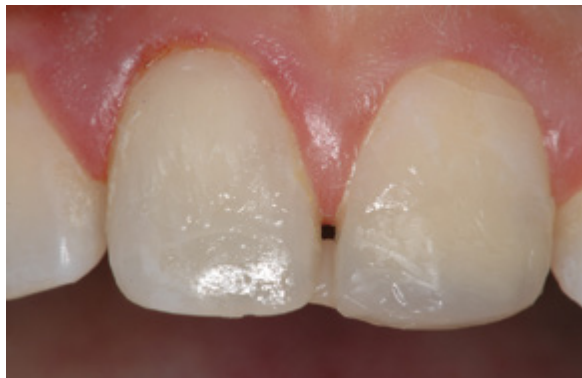
Figura 4.

At this starting and emergency time it was decided to reposition the tooth 11 and fasten it with compound

resin. A provisional restoration as made in the tooth 21 with resin and palatal splinting done for the teeth 11 and 21 (figure 04).

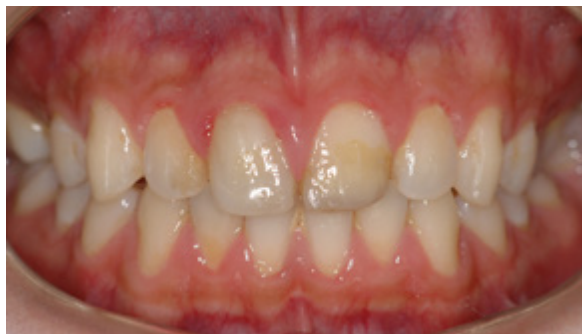
Figura 5.

After 15 days, the patient returned for control, the pulpal sensitivity to heat and cold tests were done and fortunately they were positive. However, some concern related to the mechanical resistance of the teeth remained and so the possibility of endodontic treatment for mechanical reasons were always clarified, although always rejected by the patient. It was decided to wait longer for biological and mechanical control to establish the final restorative procedure. However, after a week the patient returned with the splinting and sticking of the tooth dente 11 loose. In other words, the tooth was mechanically weakened (figure 05).

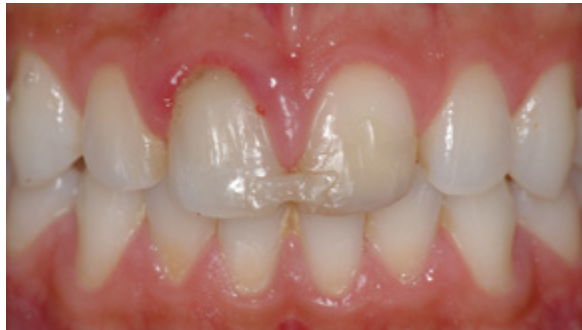
Figura 6.

At this moment, we checked the need to execute endodontic treatment of the tooth 11 for mechanical reasons, for later placing of a fiber pin for anchoring of the fractured crown. Due to the fact that its fragment only adhered by the palatal enamel, it did not have sufficient resistance. Nevertheless, the patient was very resistant and rejected this possibility. He asked us to splint the tooth again and wait longer (figure 06).

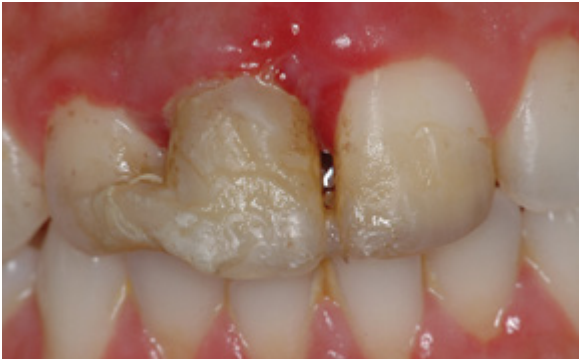
Figura 7.

A control was marked after 15 days, but the patient did not return. And 3 months went by without contact until he returned in the situation found in figure 07.

According to the patient's report, he traveled and during the trip the tooth came loose and he sought an emergency dental service resulting in this situation.

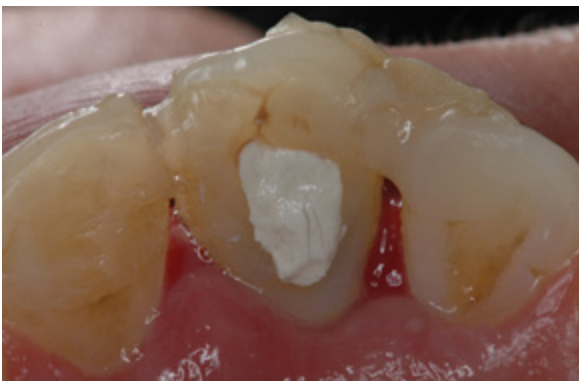
Figura 8.

Thus, due to this, there was no other alternative. He was sent for endodontic treatment (figure 08).

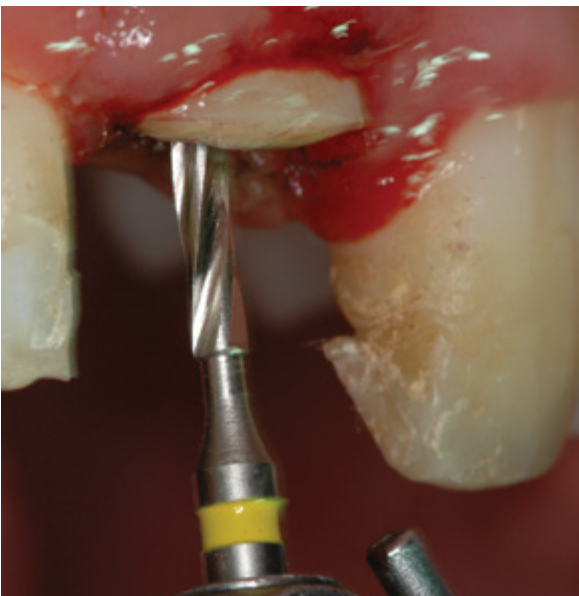
Figura 9.

After which, a fiberglass pin was placed (EXACTO – ANGELUS®) (figures 09 and 10) inside the duct associated with a prefabricate core also of fiberglass

Teeth with endodontic treatment require the placing of a fiberglass post to increase the resistance to fatigue. This procedure is essential to avoid cervical fracture of them 3,4,5,6,7.

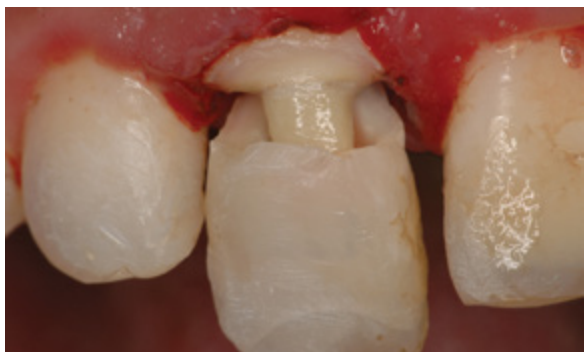
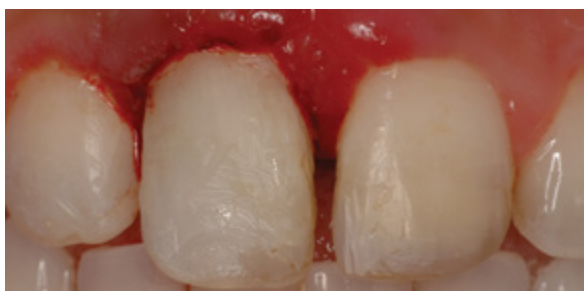
Figura 15.

This was then cemented with resinous cement (figures 15 and 16).

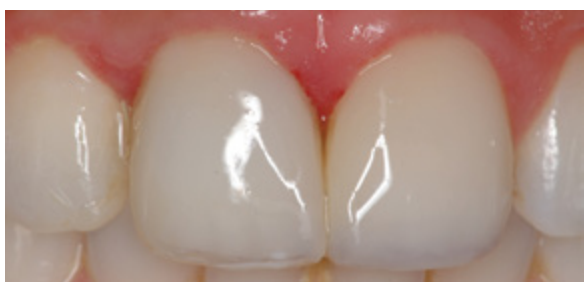
Figura 17.

After 3 weeks for gingival control the patient returned for the end restorative procedure, where 2 direct facets in compound resin were executed in the teeth 11 and 21 (figure 17).

The integration of restorative techniques and the use of the systems Exacto and Reforpost® allowed, with extreme biomechanical safety the immediate rehabilitating with compound resin of the teeth 11 and 21, granting advances aesthetics, function and shape.
