## Endodontic retreatment with root perforation using MTA repair cement and MTA based sealer.

Nayara Rodrigues Nascimento Oliveira Tavares, Jéssica Monteiro Mendes, Alexia da Mata Galvão, Maria Antonieta Veloso Carvalho de Oliveira.

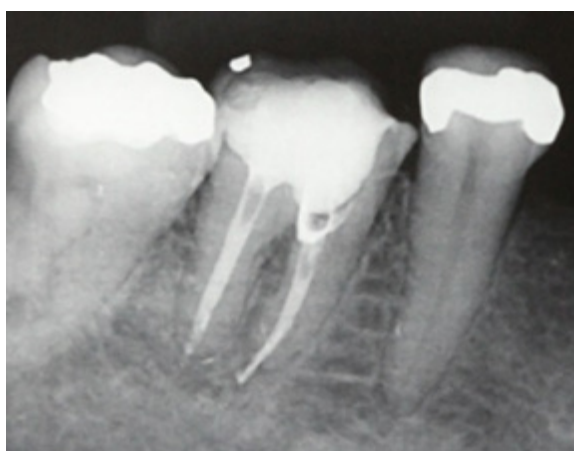
A 42-year-old female patient came to the private practice complaining of spontaneous pain on tooth number 30 (FDI 46). According to the patient file, endodontic retreatment had been performed on it. During the clinical exam, the tooth presented positive vertical and horizontal percussion tests. Radiographically it showed a lesion in the furcation region, and endodontic treatment (Figure 1).

**Figure 1: Initial x-ray.**

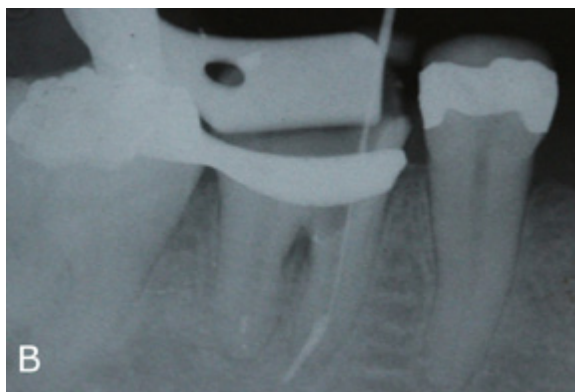
In the same session, the filling material was removed (Figure 3A) with Protaper Retreatment files in the distal canal (Denstply, Rio de Janeiro, Brazil) and Hedstroen manual files (Denstply, Rio de Janeiro, Brazil) in the mesial canal, due to suspected fracture of the file in the apical third. The fractured file was confirmed (Figure 3B) with an x-ray. Calcium hydroxide intracanal medication was placed (Biodinâmica, Ibiporã, Brazil) associated with serum (20-day interval) followed by

**Figure 3:** A. Removal of filling material. B. X-ray to confirm the presence of a separated file.

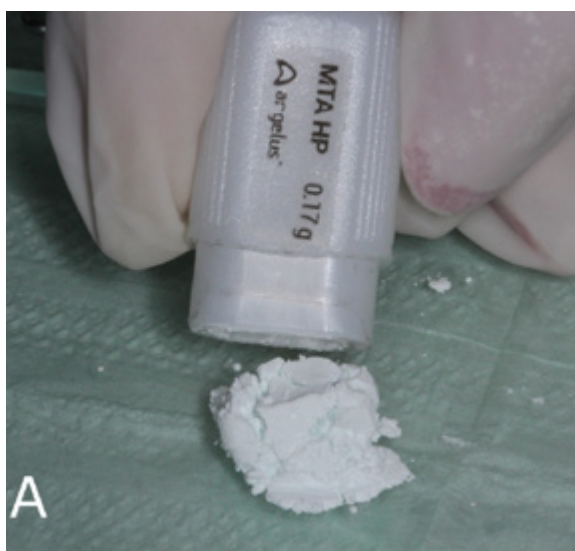
**Figure 5:** MTA HP Repair manipulation A. Powder B. Liquid C. Mixed repair cement

The MTA cement was manipulated, dispensing the first drop of liquid (distilled water), in the proportion of 3 drops of liquid to a portion of powder, reaching a homogeneous consistency (Figure 5). The cement was inserted with a small MTA applicator (Angelus Industria de Produtos Odontológicos S/A, Brazil) (Figure 6), and adapted with an insertion spatula. After verifying the adaptation of the repair cement (Figure 7A), the canals were filled with an MTA based endodontic sealer (MTA Fillapex, Angelus Industria de Produtos Odontológicos S/A, Brazil) and gutta-percha cones, using the lateral condensation technique (Figure 7B).

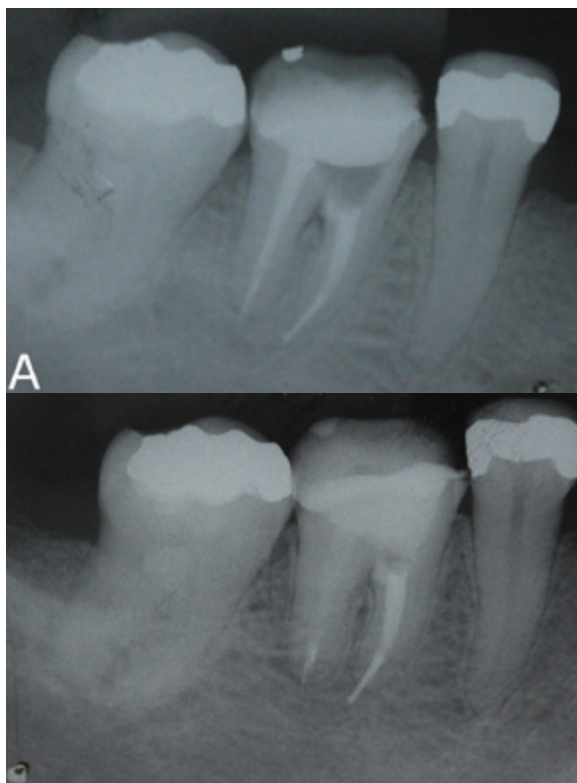
The tooth was provisionally restored. An x-ray was taken (Figure 8A). A post, buildup, and crown restoration were planned for a later session. Twelve months after the completion of treatment, the patient returned for control with no spontaneous pain, and no radiographic changes (Figure 8B).

**Figure 8:** A. Final radiography B. Follow-up after Twelve months.
