Bio-C[®] Repair

Bioceramic reparative material ready to use (putty)

BIO-C® REPAIR is a bioceramic putty ready-to-use repair cement.

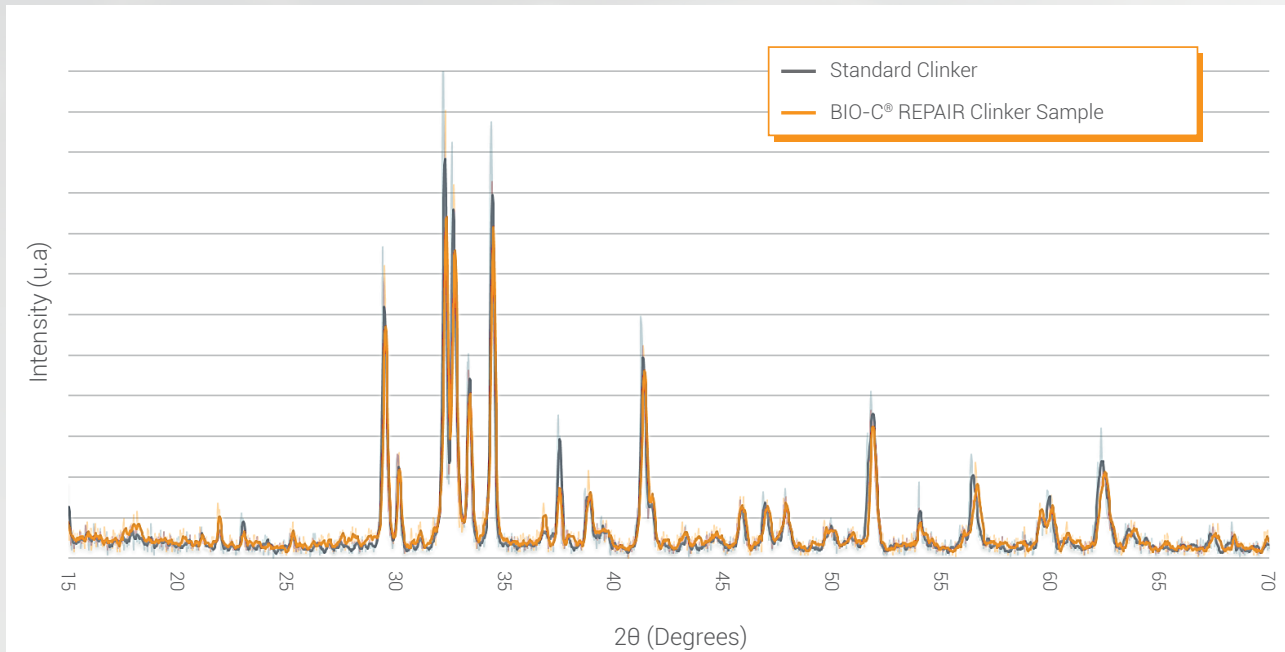
X-ray diffraction

These trials confirm the presence of Calcium Silicates, Calcium Oxide and Tricalcium Aluminate in the composition of BIO-C® REPAIR. The presence of these crystalline structures is fundamental for the product to reach the ideal physical and biological properties.

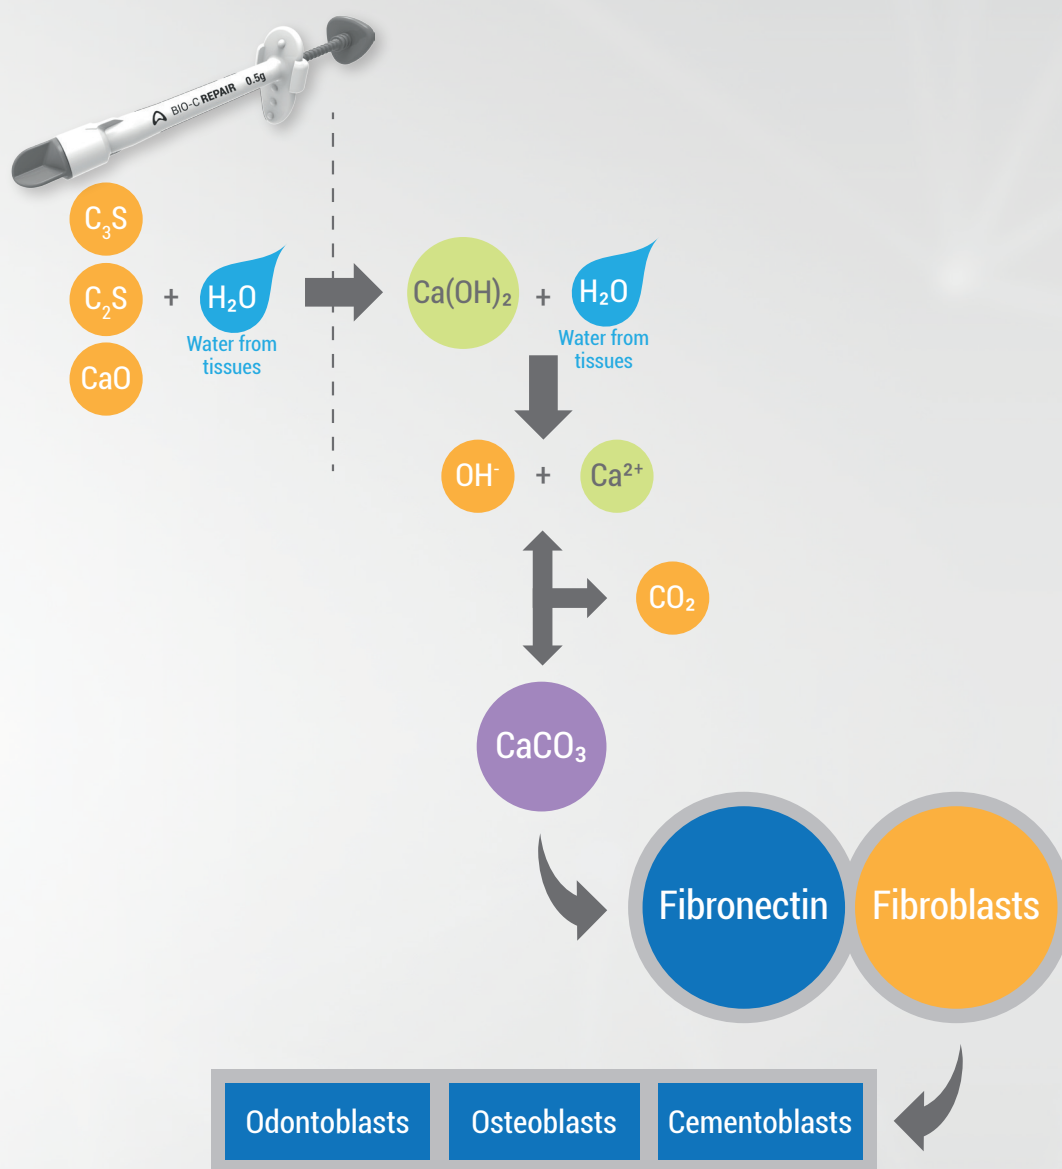
MECHANISM OF ACTION

The mechanisms of action of BIO-C® REPAIR are closely associated with contact with tissue moisture and fluids. After the Calcium Oxide, present in the formulation of BIO-C® REPAIR, comes into contact with the water present in the dentin tubules, Calcium Hydroxide is formed. Calcium Hydroxide also interacts with the fluids, dissociating in Calcium ion and Hydroxyl. The Hydroxyl ions are responsible for the pH increase, promoting bactericidal action of the product. The released Ca^{2+} ions react with CO_2 from the bloodstream, forming Calcium Carbonate (Calcite). An extracellular matrix rich in fibronectin is secreted as a result of the alkaline pH and attracted by Calcite, triggering the formation of hard tissue. Histologically, stimulation occurs to the deposition of this hard tissue, through granulations of Calcite, around which there is great condensation of fibronectin, which provides cell adhesion and differentiation.

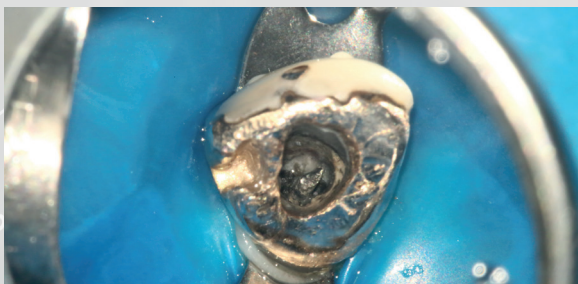
Figure 2 - View of the obturated canal of the coronary part of the silver cone

Endodontic retreatment began with access to the pulp chamber using a Predator Turbo Dental Drill (Angelus - Londrina - Brazil). The cement around the silver cone rod was removed with an E7D ultrasonic tip (Helse Ultrasonic-Brazil) (Figure 2). After exposing the coronary part of the silver cone, an E5 - Long Ultrasonic Tapered Tip (Helse Ultrasonics - Brazil) was used to vibrate the silver cone body. Although there was a low ultrasonic power adjusted to 15%, separation occurred (Figure 3). Due to the lack of adaptation of the obturation material in the apical third, part of the silver cone fragment was removed from the periapical lesion.

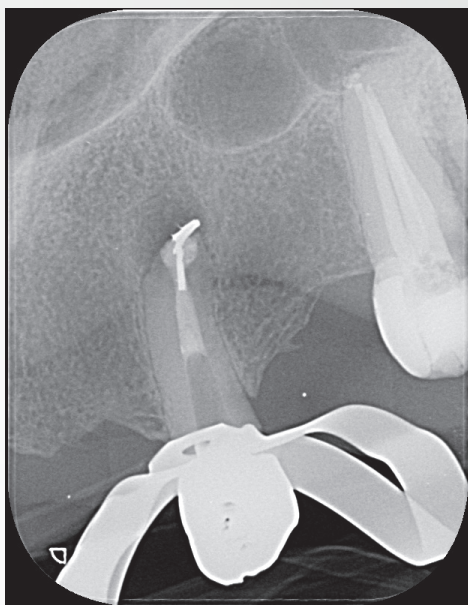
Figure 5 – Endodontic obturation

REPAIR (Angelus - Brazil). BIO-C® REPAIR is a new ready-to-use Bioceramic Endodontic Cement. It can be placed directly from the syringe into the root canal. The gutta-percha cones were compacted with a vertical cold compaction technique (Figure 5).

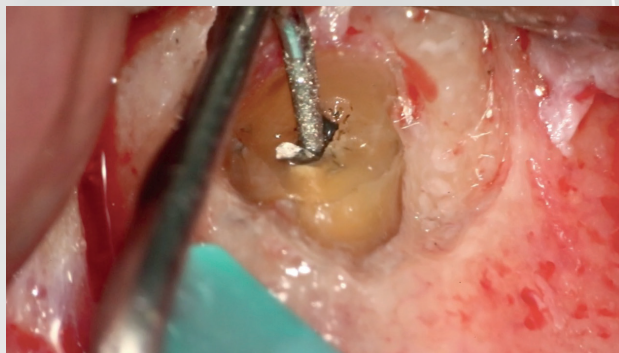
Figure 7 - Microsurgical removal of the silver cone

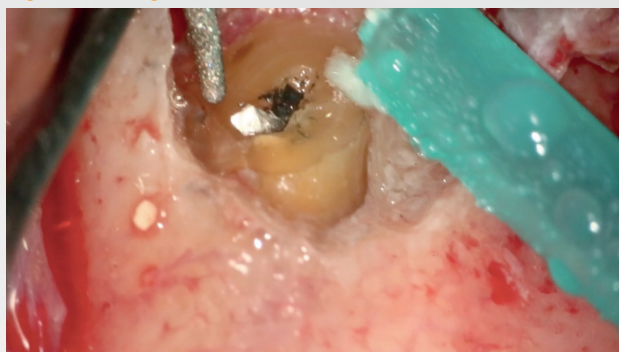
Figure 8 - Surgical removal of the silver cone

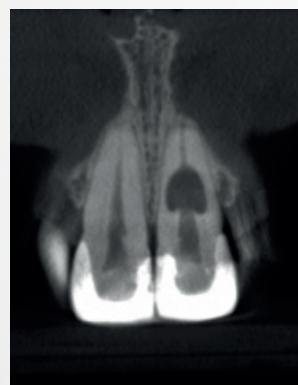
Figure 2 - Tomographic image - coronal section

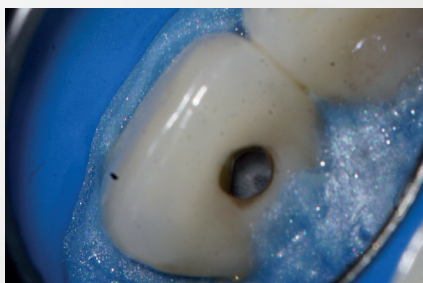
Figure 5 - Resorptive cavity

After the access, the canal was irrigated with 5% Sodium Hypochlorite followed by 17% EDTA, both with PUI and Easy clean. Through the use of the operative microscope, it was possible to visualize the extent of the resorptive cavity (Figure 5). During the chemical-mechanical preparation, we conducted abundant irrigation with auxiliary chemical substances with effective organic solvent capacity and spherical ultrasonic tip to remove and dilute the remaining pulp tissue.

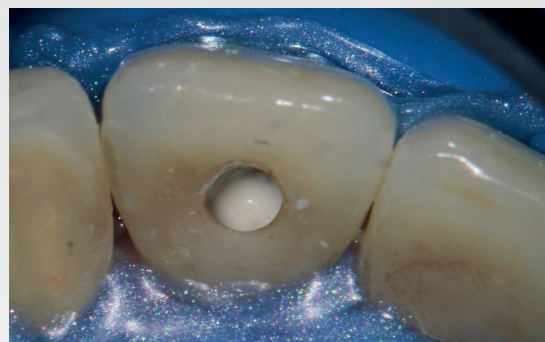
Figure 6 - Intracanal medication

The canal was then filled with a Calcium Hydroxide PA (Pro-Analysis) paste with saline (Figure 6) to chemically cauterize the tissue, which might still be present in the cavity, and to promote the necrosis of all osteorplasty units as a function of its high pH and alkalization of the medium, thus ceasing the clastic activity.

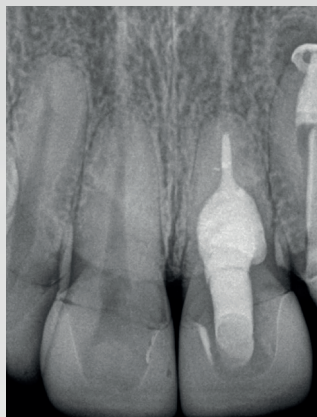
Figure 8 - Final radiography

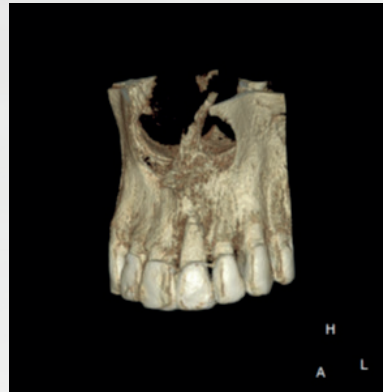
Figure 1 - Tomographic image showing extensive apical bone destruction and total loss of the cortical bone buccal wall in tooth 9

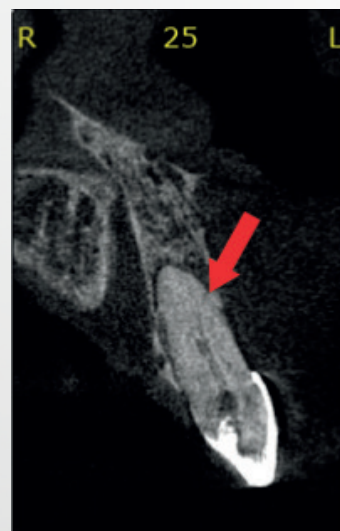
Figure 2 - Tomographic image in sagittal reconstruction showing the anatomical variation and lateral-end (distobuccal) of the apical foramen.

After conventional non-surgical endodontic treatment, it did not present regression of the lesion. During treatment, an anatomical variation was also found in the apical region of the tooth in question. This variation was confirmed by cone-beam computed tomography exam before the surgical treatment.
